Water Main Break Rates In the USA and Canada: A Comprehensive Study April 2012

Utah State University
Buried Structures Laboratory

Steven Folkman, Ph.D., P.E.

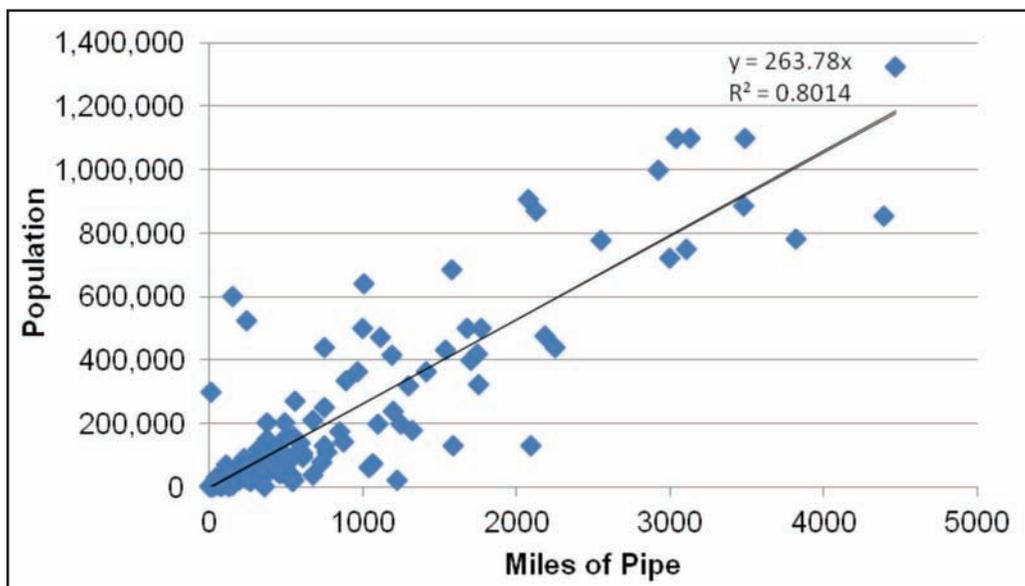
Figure 5. Population served relative to total pipe line miles from the basic survey.

Figure 5 illustrates the relationship between the population served by the utilities participating in the basic survey and the number of miles of water main pipe. The trend line and equation are a best fit to the data. The slope of this line indicates that there are on average 264 people served for each mile of water main installed.

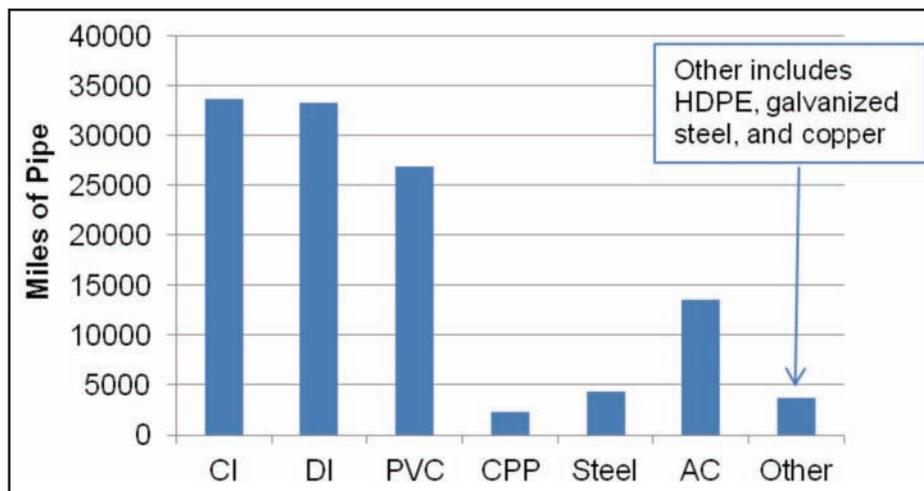
Figure 6. Length of pipe broken down by material type from the basic survey.

Figure 6 illustrates the length of pipe reported in the basic survey broken down by pipe material. The “Other” category in Figure 6 includes materials such as HDPE, galvanized steel, and copper. Figure 7 illustrates the length of pipe reported in the detailed survey broken down by pipe material. Figure 8 illustrates the pipe material distribution as a percentage of the total length from both the basic and detailed surveys. The distribution of miles of pipe is quite similar in Figure 8 indicating that the detailed survey with a smaller number of respondents still gives similar results.

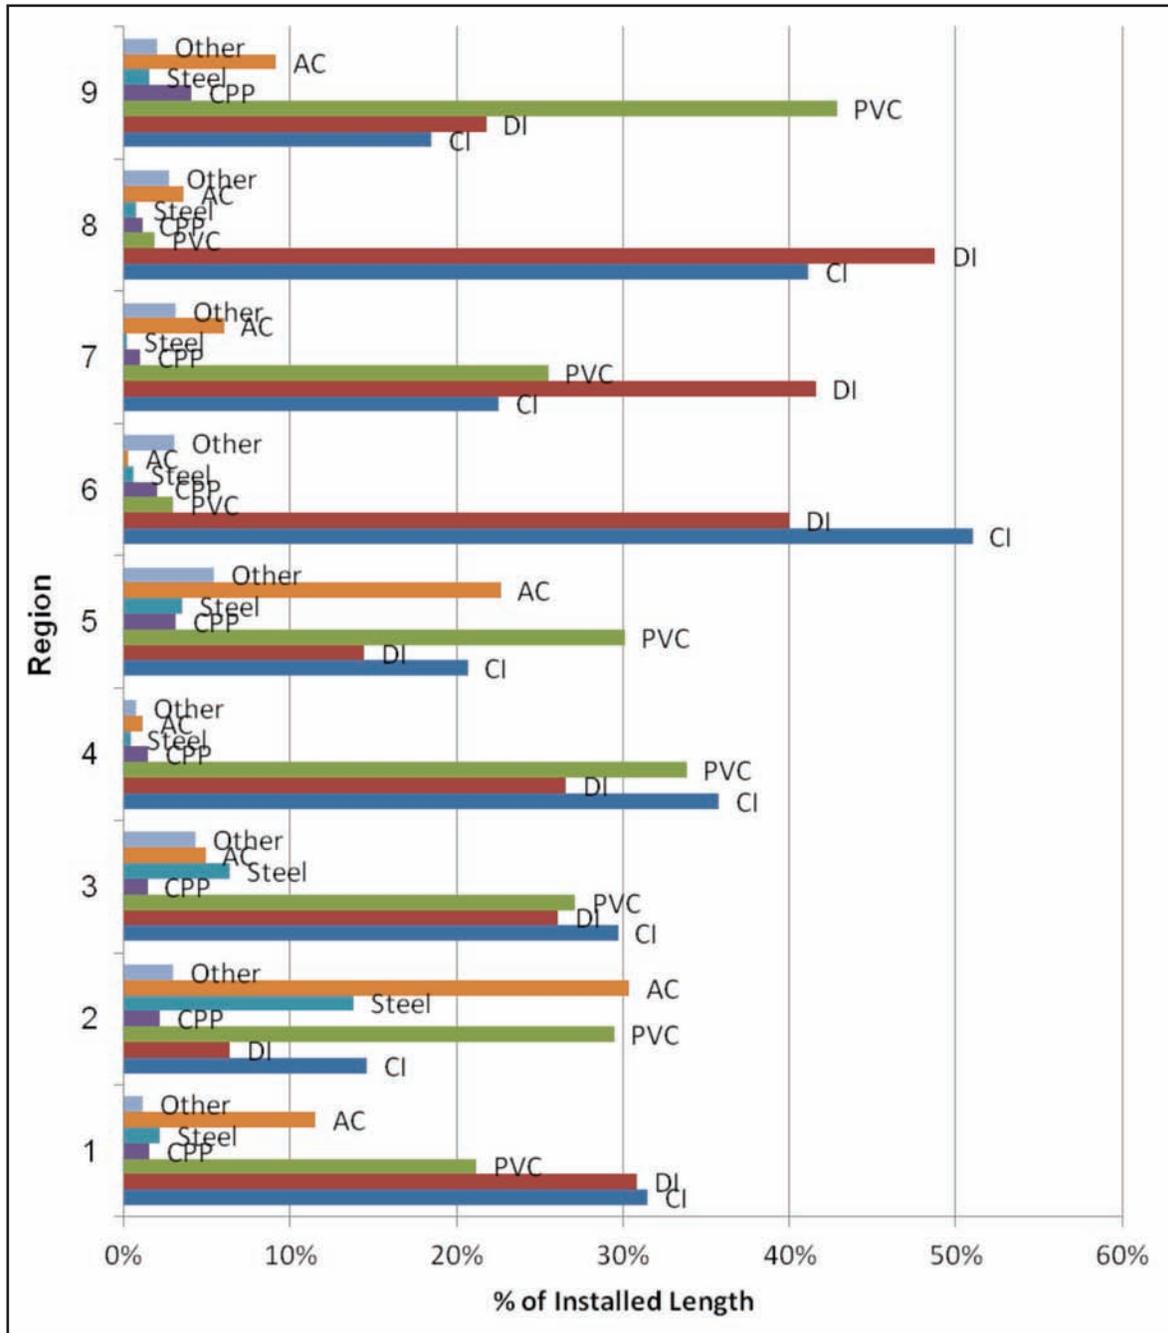
Figure 9. Regional percentage of length of pipe by material type from the basic survey.

Figure 9 illustrates the regional distribution of pipe material usage as a percentage of the total length in that region. It is interesting to note the significant differences in regional pipe material utilization. Cast and Ductile Iron represent approximately 90% of the pipe in regions 6 and 8. PVC has a dominant role in region 9 and is well established in regions 2, 3, 4, 5, and 7.

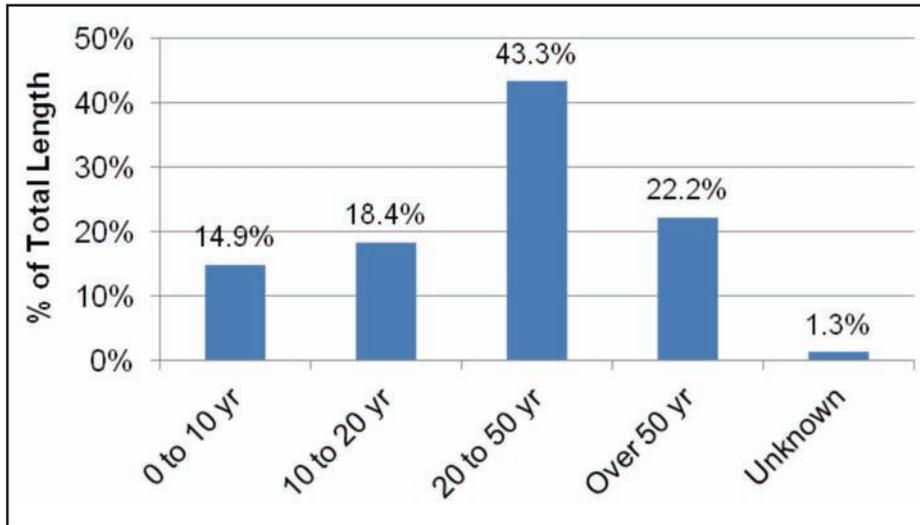
Figure 10. Percent of length of pipe by age from the detailed survey.

The detailed survey asked respondents to provide the distribution of installed pipe by age. Four age groups were provided; zero to 10 years, 10 to 20 years, 20 to 50 years, and over 50 years. Figure 10 lists the percentage of water main length that fits in each age category. Figure 10 indicates that approximately 43% of installed pipe are in the 20 to 50 year age category and 22% are over 50 years of age. This finding is consistent with other industry sources.

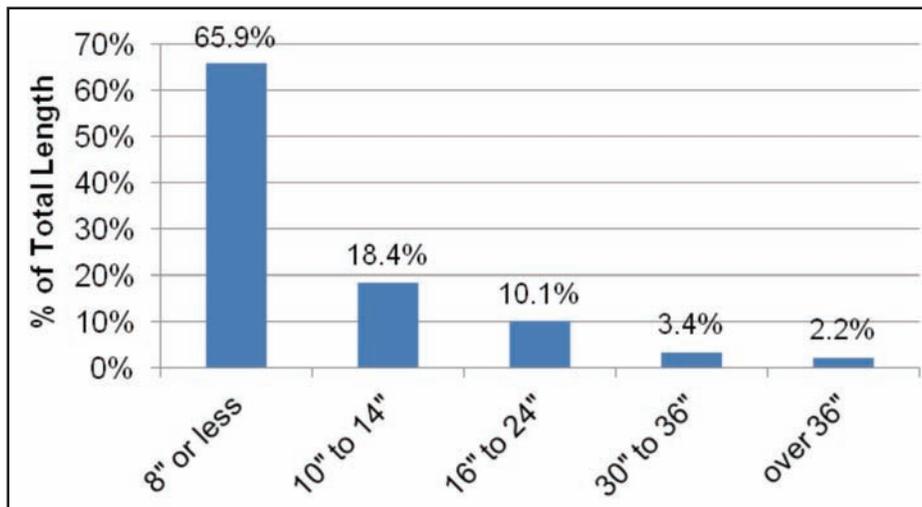
Figure 11. Percent of length of pipe by pipe diameter from the detailed survey.

The respondents were also asked to break down the fraction of total installed pipe length by five pipe diameter categories. Figure 11 illustrates the percentage of water main that fit into each size range. Figure 11 indicates that approximately 66% of the installed pipe is 8 inches or less in diameter.

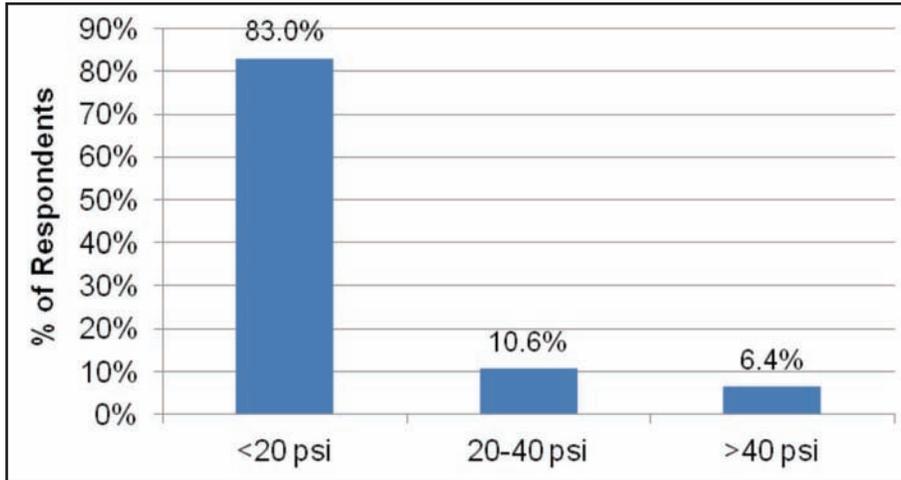
Figure 12. Percentage of respondents with one of three pressure fluctuation ranges.

Based on the detailed survey, the average delivery pressure is 77 psi. The range of values reported for average delivery pressure was 45 to 150 psi. The detailed survey also asked how much does the water pressure fluctuate at any given point in their system during a typical day. The respondents were asked to select one of three ranges. Figure 12 illustrates the percentage of respondents that fit into each pressure range. About 83% are able to limit pressure fluctuations to be less than 20 psi.

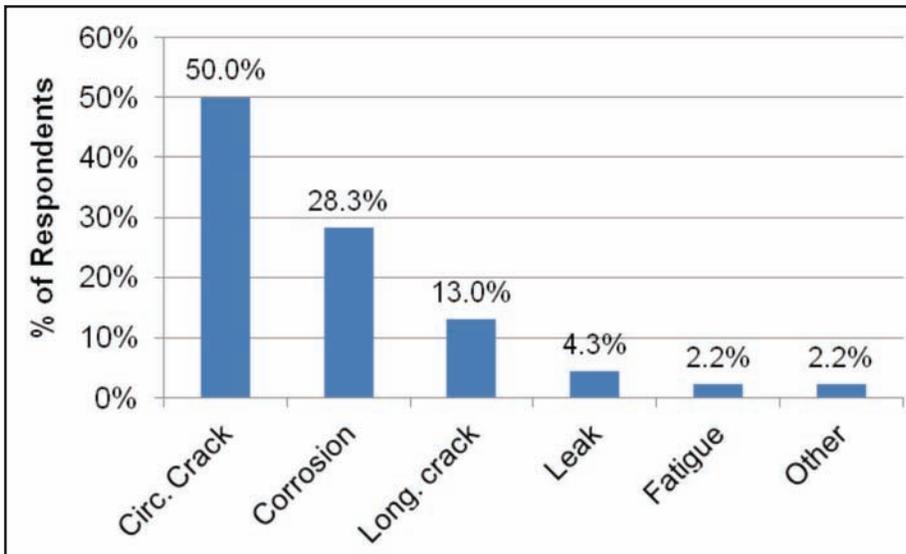
Figure 13. Percent of respondents selecting a most common failure.

The detailed survey asked the respondents to identify the most common failure mode by selecting from one of the following; corrosion, circumferential crack, longitudinal crack, leakage at joints, fatigue, or other. Figure 13 identifies a circumferential crack as the most common failure mode followed by corrosion. The detailed survey also asked respondents to identify the pipe material that was failing most often. Figure 14 shows that 55.3% of respondents identified Cast Iron as the most common failing pipe material followed by Asbestos Cement at 17.0%. The respondents also reported the typical age of a failing water main. The average result was 47 years with a range of values from 20 to 86 years. The survey also asked what the expected life should be when installing new pipe. The average expected life of new pipe was 79 years with a range of responses from 30 to 200 years.

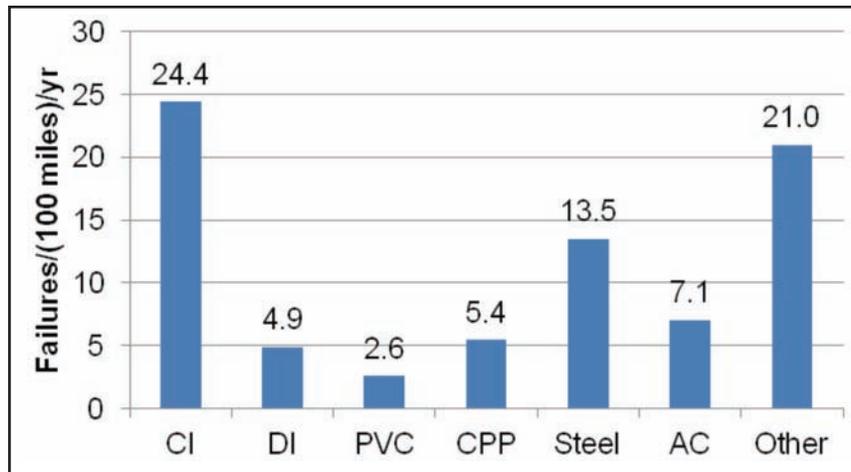
Figure 15. Failure rates of each pipe material from the basic survey.

The survey measured pipe failures over a recent 12 month period, broken down by material type. Table 4 lists the total length of pipe by material type, the number of failures over a recent 12 month period, and the failure rate for each pipe material. Figure 15 illustrates the failure rates as a function of material type. If one assumes a utility had equal lengths of each material installed, then Figure 16 would illustrate the percentage of failures as a function of pipe material. Figure 17 gives the failure rates broken down by material type and by respondents from the USA and Canada.

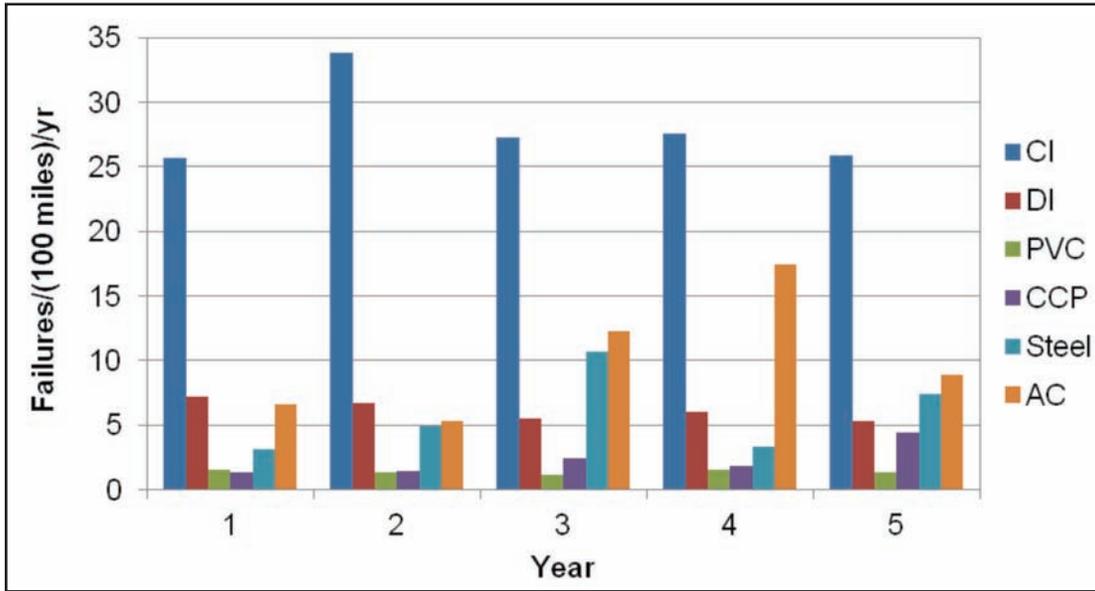
Figure 18. Pipe failure rates over a five year period as a function of pipe material.

The detailed survey requested the respondents to list the number of failures per year for five years, broken down by material type. The desired focus was to examine the year to year variations by pipe material. A single utility might have large year to year variations, but if the number of utilities sampled is sufficient, the year to year variation should be small. Figure 18 shows the failure rates from the detailed survey from each of the five years covered by the survey. Respondents that did not have five years of data were not included in these results.

Table 5 lists the average of the failure rates over the five year period along with the standard deviation and the coefficients of variation (the standard deviation divided by the average). The coefficients of variations for CI, DI, and PVC are similar indicating they have approximately the same variability. The widest variation in rates was associated with CPP, steel and AC pipe. The length of pipe in the detailed survey for these materials was small and more respondents could likely reduce the variability.

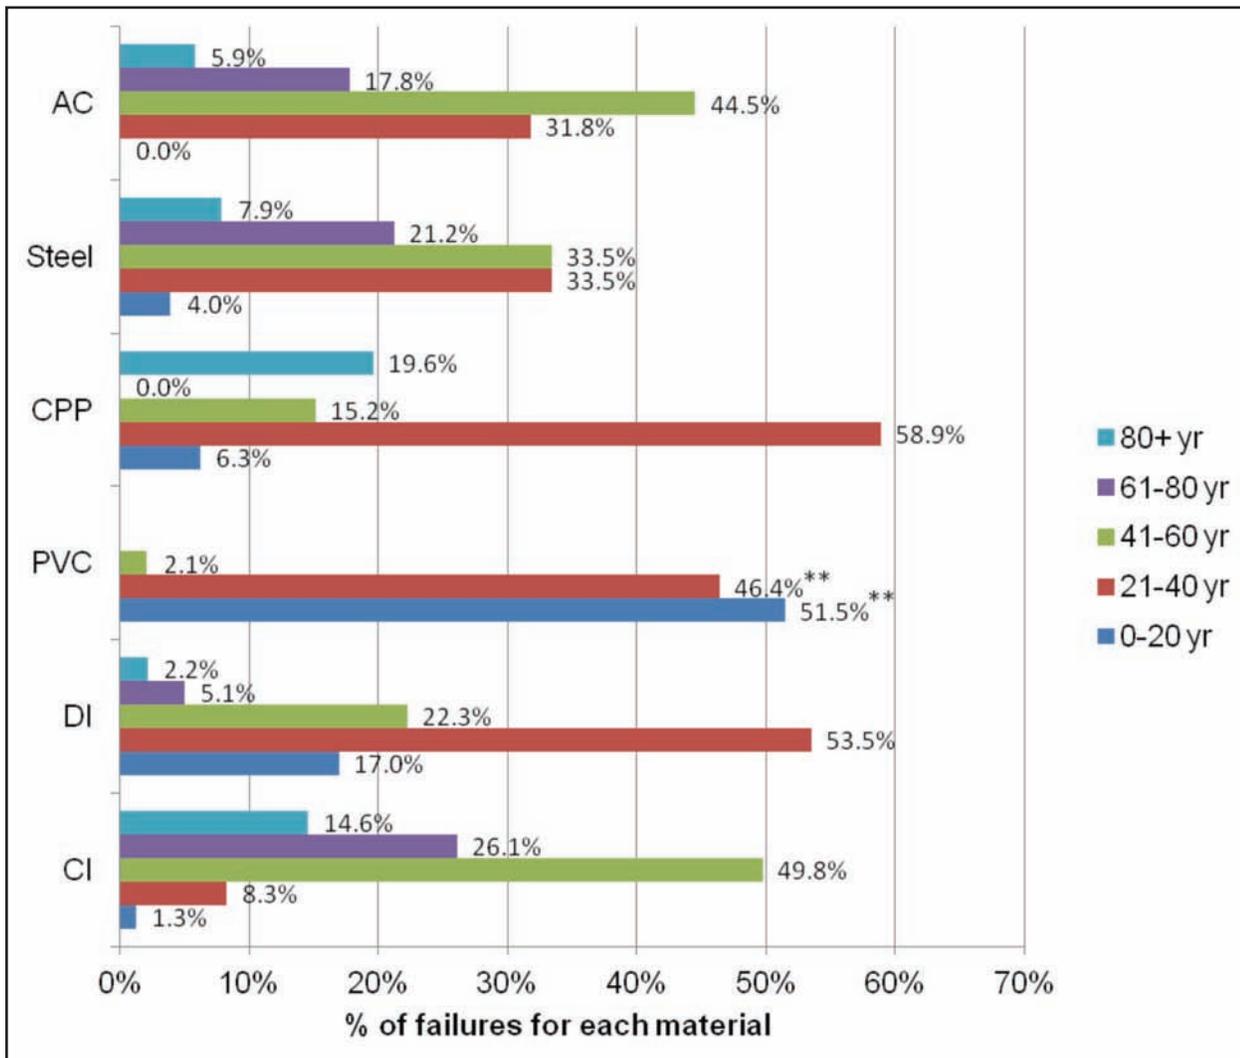
Figure 19. Percent of failures as a function of age and pipe material.

Clearly, pipe age will affect failure rates. The basic survey asked respondents to break down the failures into five different pipe age categories. It is noted that some of the respondents did not know the age of the failed pipes, and they were not included in the results below. For each material type, the fraction of failures in each age group is examined in Figure 19 based on the basic survey results. For example, 49.8% of the reported cast iron failures occurred with a pipe age between 41 and 60 years. Note that the largest percentage of failures is not in the oldest pipes, which has several possible causes. First, the older pipe is being replaced, and, thus, there is less available to fail.

The results in Figure 19 are related to when a pipe material was introduced or removed from the market. Asbestos Cement pipe has not been installed in the USA and Canada in the past 20 years, and, thus, all AC pipe failures exceed 20 years of age. Widespread DI and PVC pipe production in the USA did not start until about 1970, so we should expect to see a small failure percentage for both DI and PVC in the 41 to 60 year age group and none for the 61 to 80 and 80+ age groups. PVC follows that trend in Figure 19. Figure 19 shows the majority of DI pipe failures occur at an age between 21 and 40 years. The DI results in Figure 19 for the 61 to 80 and the 80+ age groups are possibly caused by incorrect records on the age of those failed pipes.

It is of interest that Figure 19 shows a greater percentage of PVC pipes fail in the first 20 years of use than in the next 20 years**. This was investigated in a previous survey funded by AWWARF (Moser, 1994). Figure 20 illustrates the percent of failures as a function of time for AWWA rated PVC pipe. As shown below, over 40% of the reported failures occurred in the first year. Often the cause of these failures in PVC pipe is related to improper installation practices and not a defect in the pipe. The city of Calgary has been able to achieve remarkably small PVC failure rates due to enforced construction standards (Brander, 2004). In addition, Calgary requires new subdivision infrastructure to remain the property of the private developer for a period of two years. During this two year period, most construction related problems will occur. An AWWARF study (Burn, 2006) estimates the design life of PVC to be in excess of 110 years.

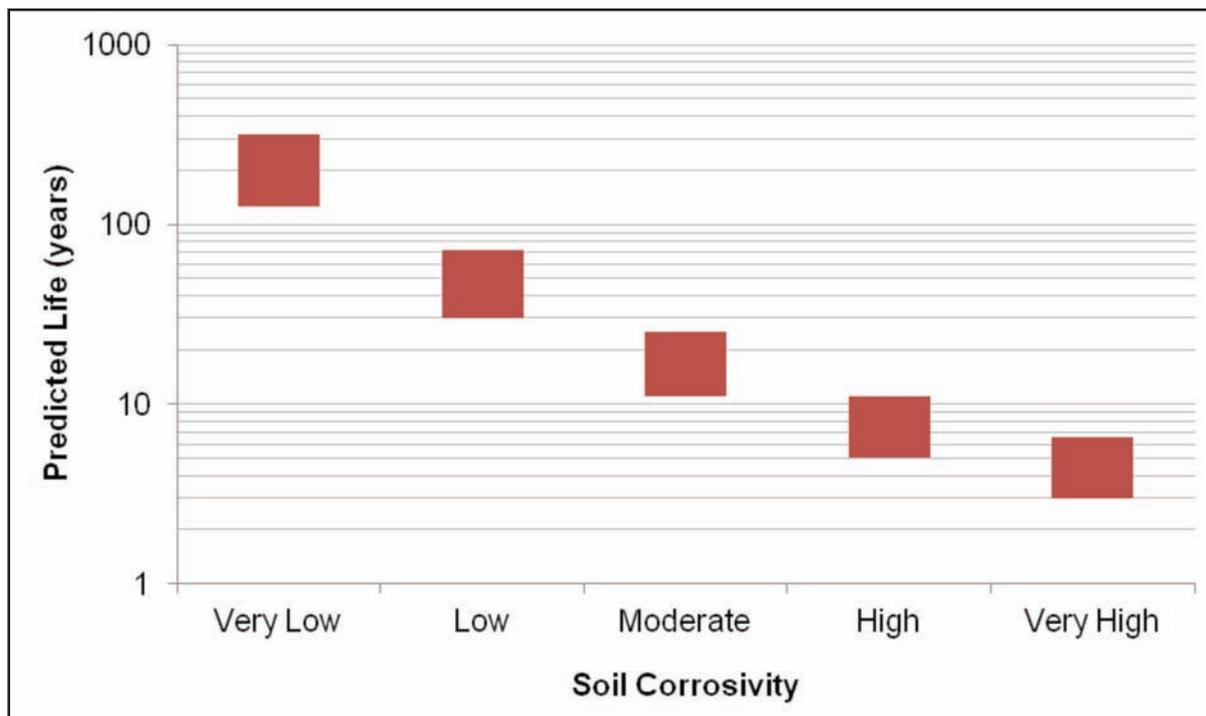
Figure 21. Predicted life of unprotected class 350 DI pipe (from Rajani, 2011).

The expected life in years of an unprotected DI pipe was estimated in a recent Water Research Foundation study (Rajani, 2011). Figure 21 illustrates the published results as a function of a relative scale of soil corrosivity. Figure 19 indicates that the majority of DI pipe failures occur at an age between 21 and 40 years. A 21 to 40 year life in Figure 21 would correspond to a low to moderate soil corrosivity for an unprotected pipe. This would indicate that corrosion is a significant problem in all regions of this study. When a comparison is made between Cast Iron and Ductile Iron, thinner-walled Ductile Iron is experiencing failures more rapidly (21-40 year period) than the thicker-walled cast iron (41-60 year period). Concrete Pressure Pipe also shows failures rates that are impacted by corrosion in the 21-40 year period. The study also notes that “aging or deterioration of ductile iron pipes can vary significantly from one geographical region to another within a city, let alone from city to city.”

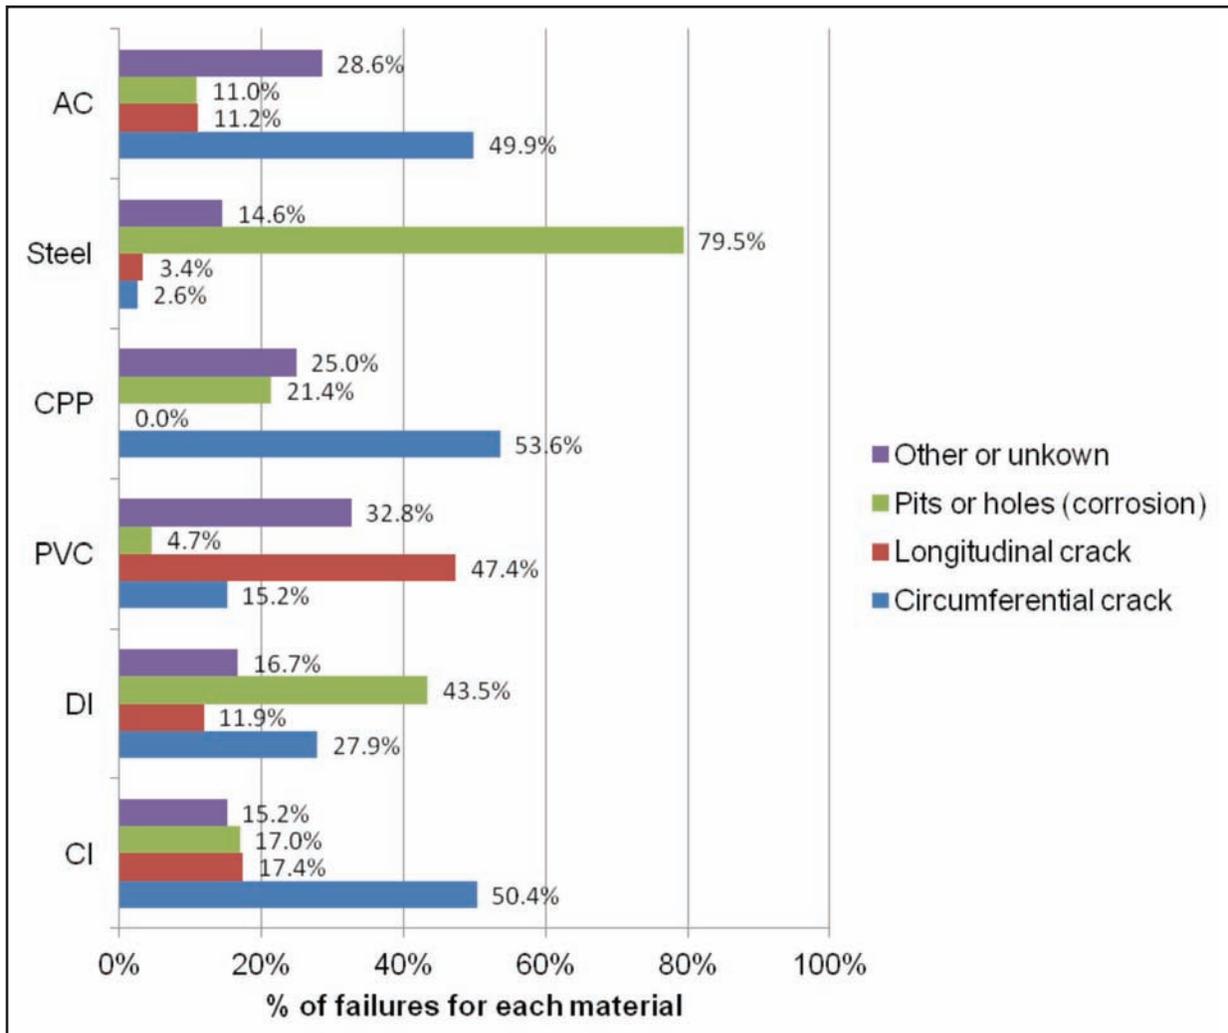
Figure 22. Description of failure for each pipe material.

Figure 22 summarizes the percentage of failures that were reported to fit in each description. A circumferential crack is the primary failure mode for Cast Iron, Concrete and Asbestos Cement pipe. Corrosion is the primary failure mode of Ductile Iron and Steel pipe. A longitudinal crack is the primary failure mode of PVC.

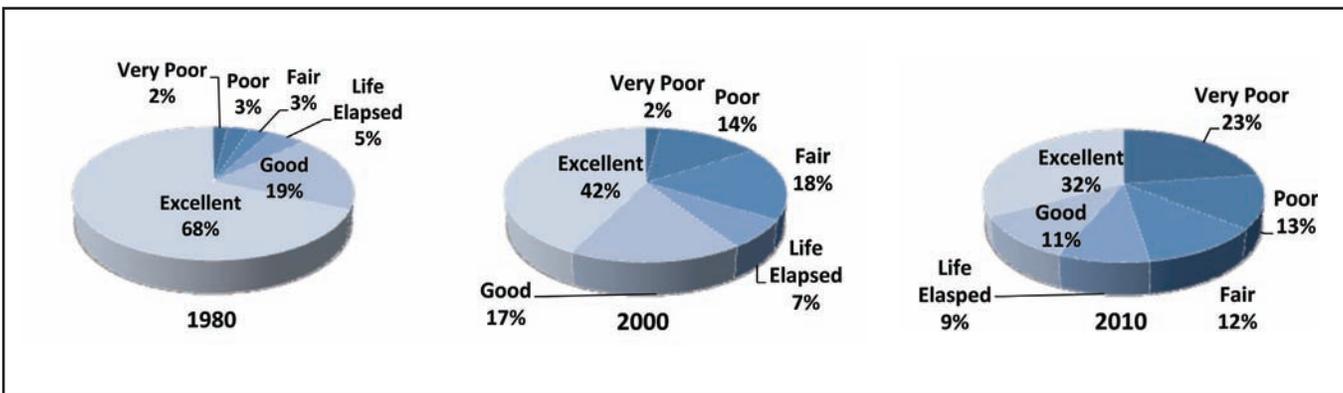
Figure 23. Assessment of pipe condition with time (from EPA, 2002).

It is of interest to compare these results with a study done by the EPA (EPA, 2002). This study classified water main pipe condition into six categories; Excellent, Good, Fair, Poor, Very Poor, and Life Elapsed. The study examined data for years 1980 and 2000 and forecasted data for 2020. Figure 23 below is reproduced from their report and shows that the above mentioned survey average response of 8.4% of pipe are beyond their useful life would correspond well with the “Life Elapsed” category in Figure 23. It is very important to note the projected growth in the “Very Poor” condition category in Figure 23. The rate of growth in that category will make it much more difficult for utilities to get that pipe replaced before it reaches the “Life Elapsed” category. An AWWA study (AWWA, 2012) echoes this trend as illustrated in Table 6. Table 6 shows aggregate costs to cover both replacement and growth in water mains in the USA.

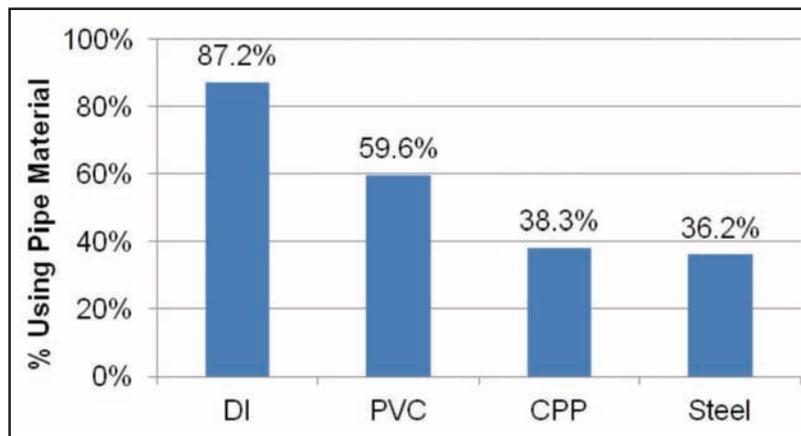
Figure 24. Percent of respondents that will allow installation of these water main pipe materials.

The detailed survey also asked what water main pipe materials are currently excluded from being installed at their utility. Figure 24 illustrates the percentage of respondents that allow a particular pipe material to be installed. The reasons used for excluding a pipe material were also requested in the survey. Table 7 summarizes the most common comments made for exclusion of a pipe material.

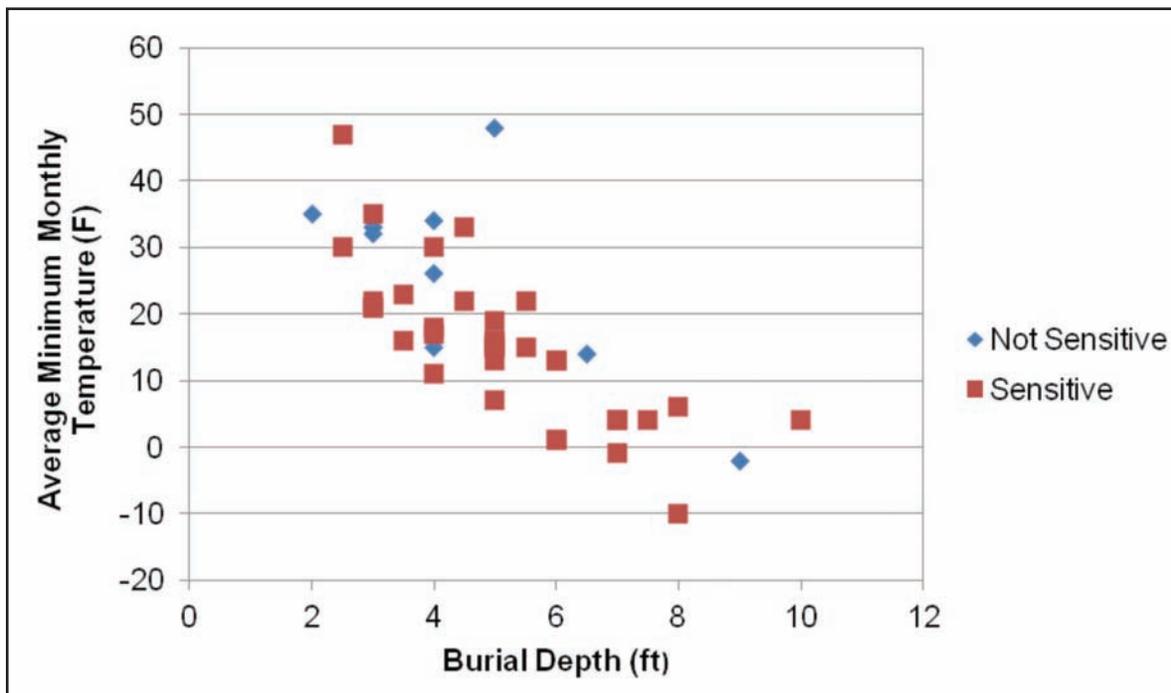
Figure 25. Correlation of the lowest average minimum monthly temperature during the year and burial depth. Red symbols note locations where failures increase with low ambient temperatures.

Figure 25 plots the lowest average minimum monthly temperature during the year for each respondent versus their reported average burial depth. The utilities with the blue symbols indicated they are not sensitive to cold ambient temperatures and the red colored symbols are sensitive. It was thought that with sufficient burial depth, the low temperature sensitivity might be reduced, but the data in Figure 25 does not support that conjecture.

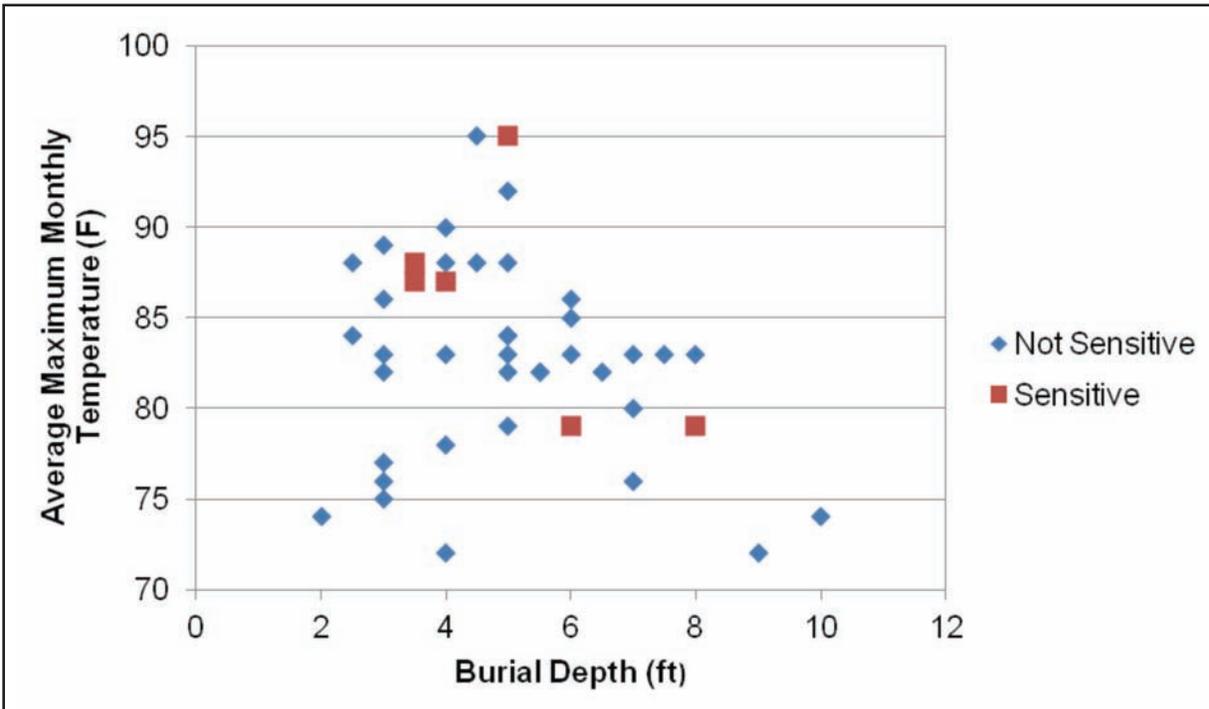
Figure 26. Correlation of the highest average maximum monthly temperature during the year and burial depth. Red symbols note locations where failures increase with high ambient temperatures.

Figure 26 plots the highest average maximum monthly temperature during the year for each respondent versus their reported average burial depth. Again, the color of the symbol indicates whether that utility reported to be sensitive to high ambient temperatures. Again, no correlation was observed.
